WELL CONTROL INCIDENT ANALYSIS

EOG Resources Inc.

Punxautawney Hunting Club 36H

July 2010

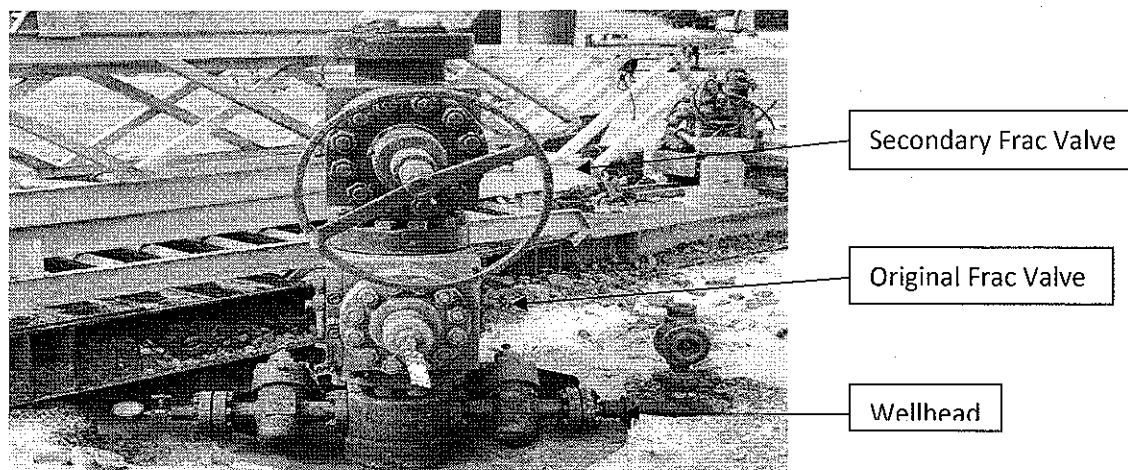
5-1/8" – 10,000 psi WP Frac Valve

The lower orange valve is the original 5-1/8" – 10,000 psi WP frac valve which was installed prior to the frac on the wellhead and remained in place during the well control incident. It is a full opening valve and requires 33 rounds to fully open or close the valve. The hand wheel has been removed.

The upper green valve was installed after the removal of the flow cross and BOPS after the well control incident was secured. This was done for safety reasons in the event the lower valve failed.

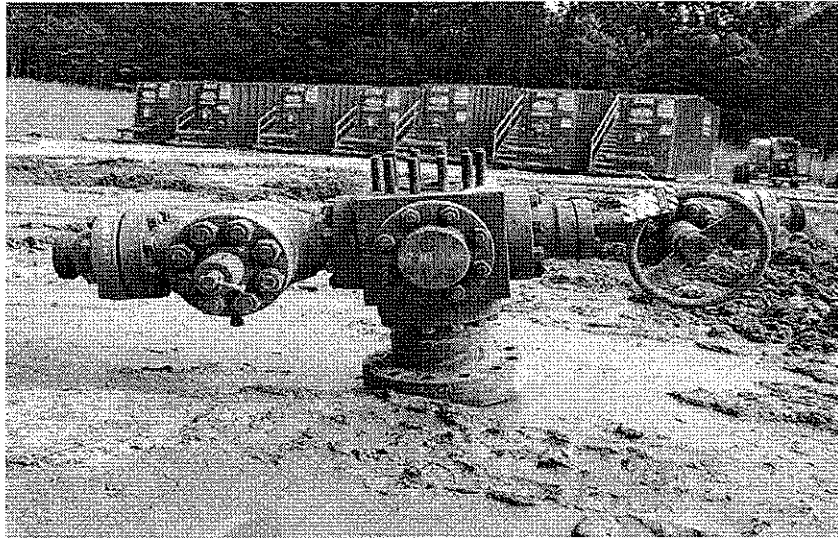
5-1/8" – 10,000 psi WP Flow Cross

The 5-1/8" – 10,000 psi WP flow cross was installed on top of the frac valve before starting the post-frac cleanout operations. The cross allowed frac fluid and brine to be flowed up the 5-1/2" casing x 2-3/8" tubing annulus.

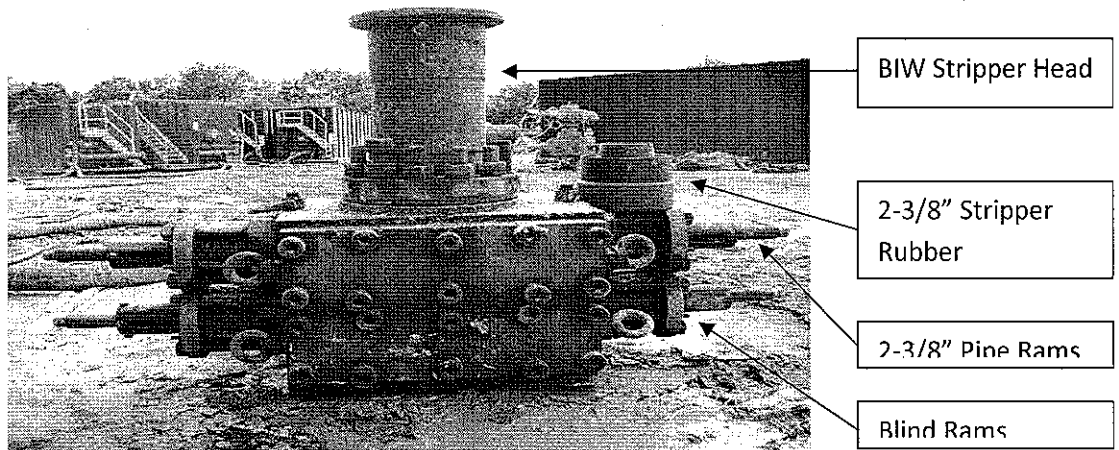
7-1/16" – 5,000 psi WP Dual Ram BOP

The 7-1/16" – 5,000 psi WP Dual ram BOP with Beaumont Iron Works (BIW) stripper head was installed on top of the 5-1/8" – 10,000 psi WP flow cross. A cross – over was required for proper make-up. Blind rams were installed in the lower rams and 2-3/8" pipe rams were installed in the upper rams.

The BIW stripper head has a 7-1/16" – 5,000 psi WP flange so it can bolt up to the BOP. The 2-3/8" stripper rubber is not pressure rated by the manufacturer due to the fact that as soon as it is used it would be downgraded because of wear. Therefore, it cannot be considered a pressure barrier during workover operations.

On the EOG PHC 36H, the decision to pull the 2-3/8" tubing through the 2-3/8" pipe rams after the stripper rubber (which should not of been considered a barrier) had failed, was flawed and ultimately led to the well control incident. This is especially true with +- 1500 psi pressure underneath the pipe rams and 0 psi pressure between the pipe rams and failed stripper rubber.

3. The 7-1/16" – 5000 psi WP dual rams were not tested before use and improperly tested once well pressure was applied to them. This puts in question the condition of the blind and pipe rams before the operations started.

Stripper heads should not be counted as pressure barriers in any post-frac cleanout operation or any well activity.

2. Recorded test results (chart record) of any BOP equipment utilized in post-frac cleanouts should be on file at the wellsite or with the wellsite supervisor. This test should be performed immediately after the installation of the BOP equipment and before its use.

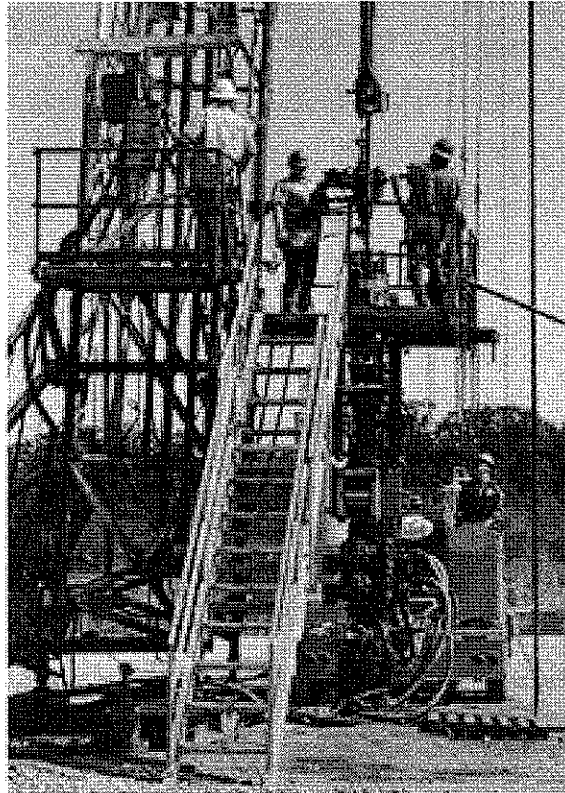
7-1/16" – 5,000 psi WP Rig Assist Snubbing Unit

A snubbing unit is designed to push or pull pipe from a well while under pressure. The units typically consists of a power unit, jack assembly, a 5,000 psi WP annular preventer and either one or two sets of ram type preventers. The rig provides the lifting capacity for the snubbing unit. Most rig assist snubbing units are truck mounted for ease of mob and de-mob.

Rig Assist Snubbing Unit – During the post-frac clean-out process on horizontal wells, the common practice is to utilize coil tubing to drill out the composite plugs between frac stages. EOG started the clean-out process with a 2" coil tubing unit and was able to drill up 11 of the 15 composite plugs in the hole. Due to friction between the coil tubing and the casing in the horizontal hole, the coil was not able to drill the remaining 4 plugs. EOG made the decision to use a workover rig, 2-3/8" tubing and a power swivel to drill up the remaining 4 plugs plus the upper composite plug used to seal off the open perforations while going in the hole. Using a rig and power swivel can be acceptable if proper pressure barriers are in place. However, a snubbing unit must be used after drilling out the composite plugs to pull the tubing from the well and to run in the hole with the production tubing. A much safer plan would be to rig up a rig assist snubbing unit once the coil tubing cannot go deeper in the well. This is true especially since a snubbing unit must be used anyway to finish the operation. While there would be a minimal additional cost, it would be a much safer operation as a snubbing unit is designed for the purpose of running and pulling tubing in a well under pressure.

3. The use of a snubbing unit (stand alone hydraulic or rig assist) to perform post-frac cleanouts if coil tubing is not able to clean out the composite frac plugs and sand to total depth should be highly recommended. A snubbing unit is designed to run and pull tubing in and out of a well under pressure.
